Manhole Inspection Summary

Manhole # S31G__013MH

Insp Date: **8/11/08 11:21 AM**

Location Address: **10 w baltimore st**

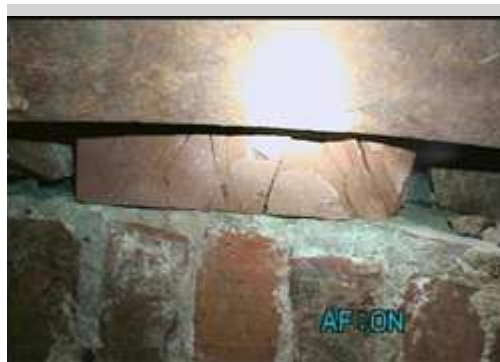
Defect 3

Condition: ☐ Sound ☐ Cracked ☐ Root Intrusion ☒ **Loose Brick** ☐ Deteriorated

chimney loose bricks, frame adj

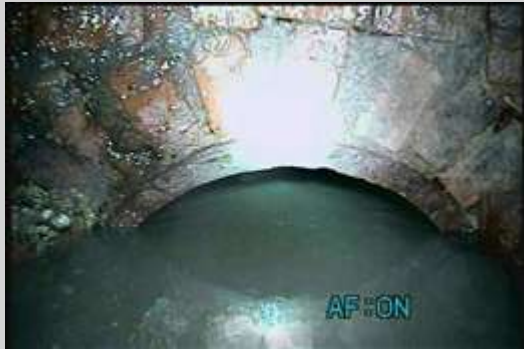
12 O'Clock Outflow

15 in. Circular Gravity Sewer
Pipe Out @ 12 O'Clock

Pipe Material: **Clay** ☐ Pipe Lined

Invert Depth: **19.10** (ft.) Flow Characteristics: **Fast**

Infiltration: **None** Pipe Seal Cond: **Unknown**

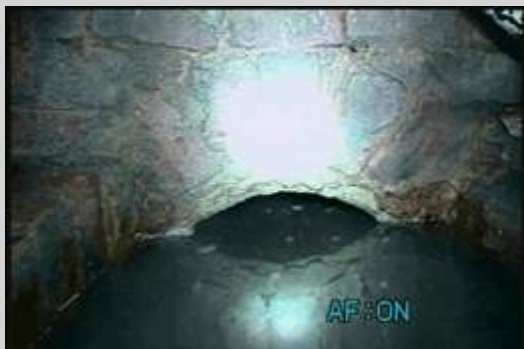
3 O'Clock Inflow

10 in. Circular Gravity Sewer
Pipe In @ 3 O'Clock

Pipe Material: **Clay** ☐ Pipe Lined

Invert Depth: **18.66** (ft.) Flow Characteristics: **Fast**

Infiltration: **None** Pipe Seal Cond: **Unknown**

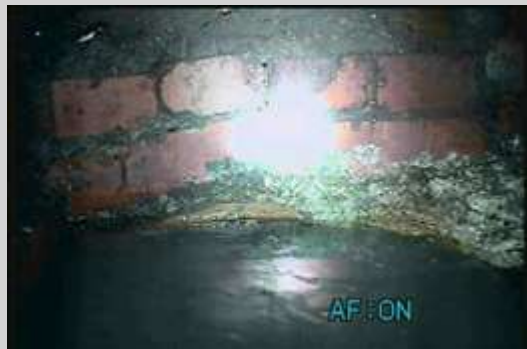
9 O'Clock Inflow

16 in. Circular Gravity Sewer
Pipe In @ 9 O'Clock

Pipe Material: **Unknown** ☐ Pipe Lined

Infiltration: **None** Pipe Seal Cond: **Unknown**
